LOW COST LOAD CELL TESTING

Low Cost Load Cell Testing

Technical White Paper

Phil Roch – Marketing Executive, Straightpoint (SP)
October 2018

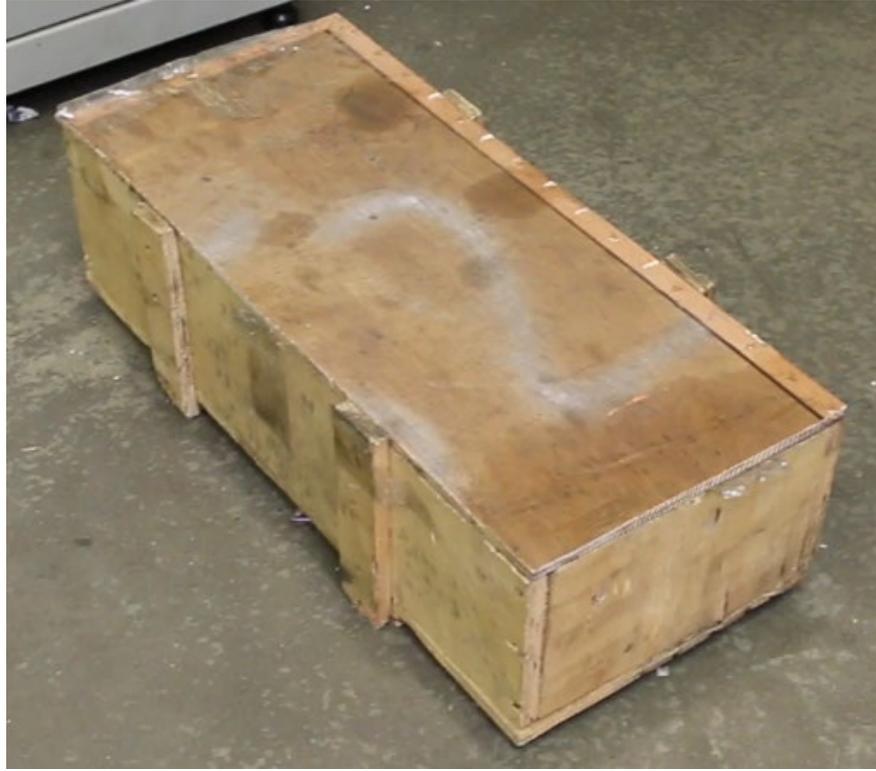
Packing crate upon arrival - before opening

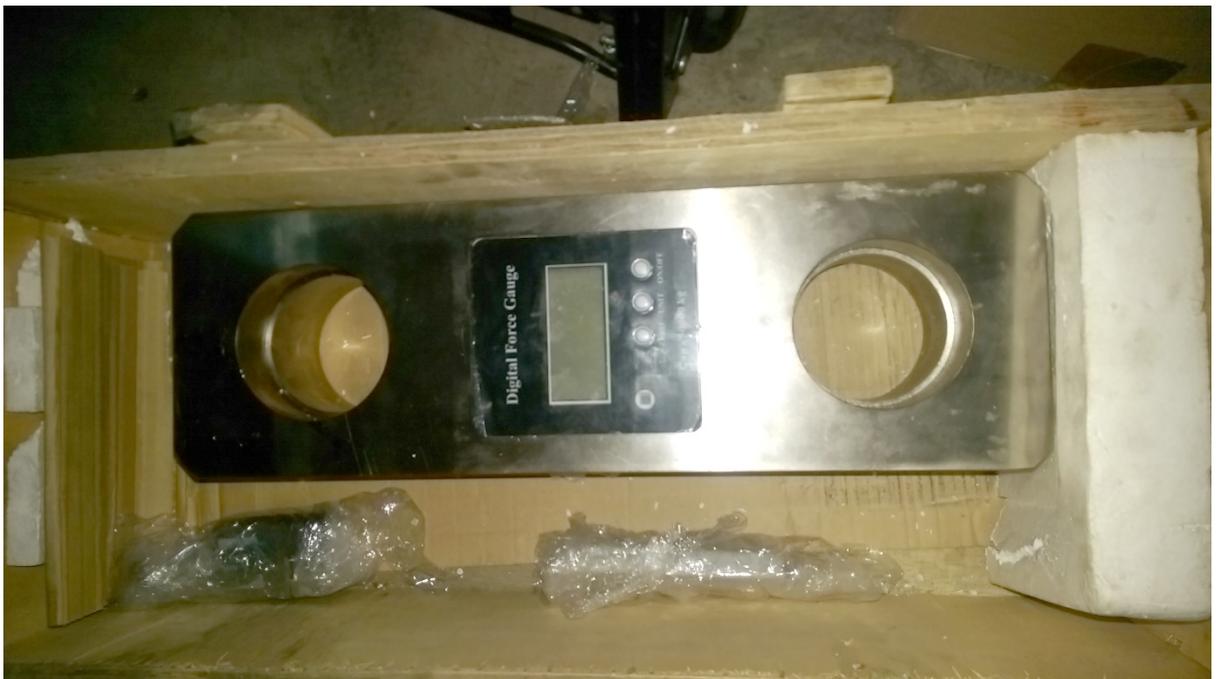
Photo taken when packaging crate was opened (“Calibration Certificate” and instruction manuals removed to reveal entire load cell)

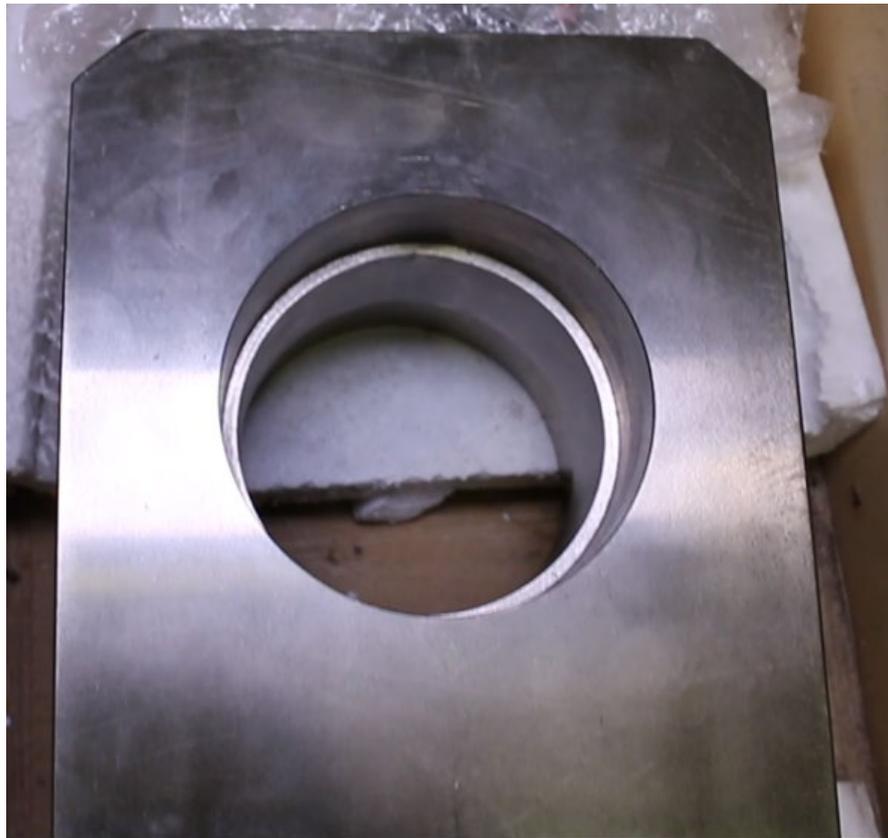
Top section

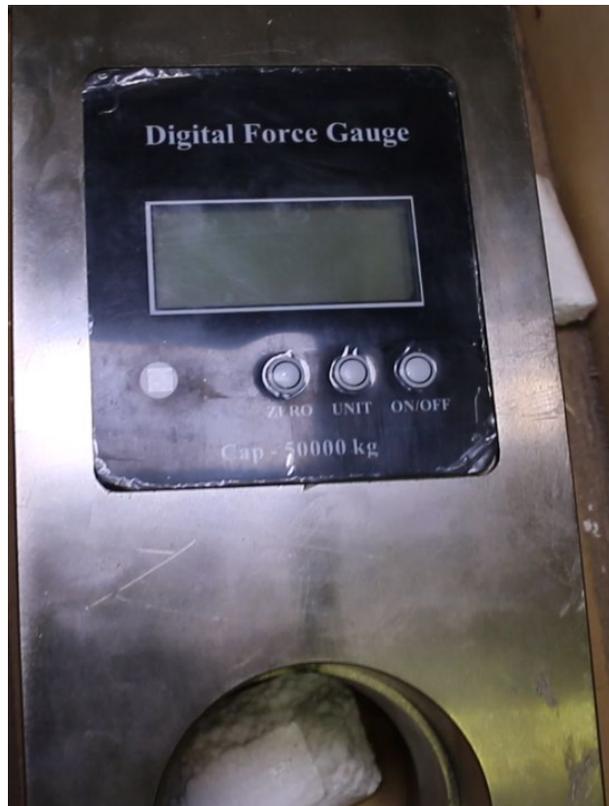
Digital display and onboard functions

- It appeared that little care was taken to preserve condition during warehouse storage of the product beyond the production stage.
- On board control and LCD panel not sitting flush within metal body; there was a gap showing all the way around it.

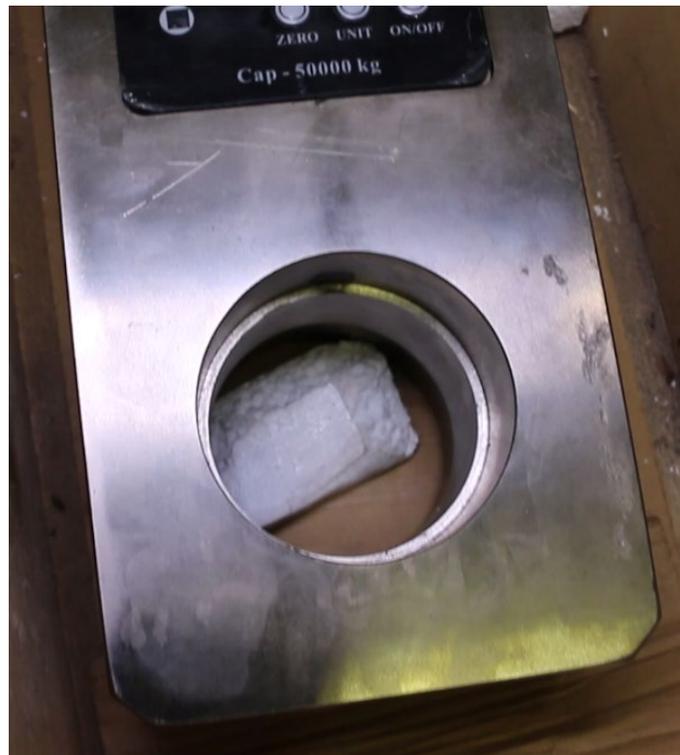
Lower section

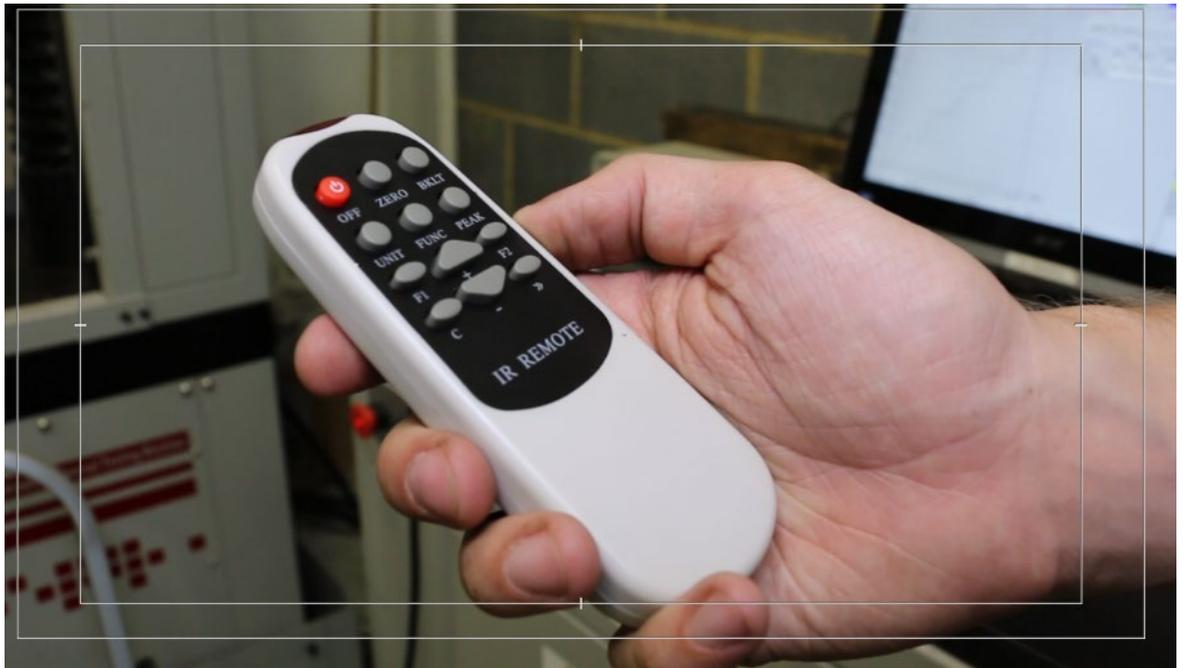
“First impressions of the load cell are not good; it’s unnecessarily large and heavy, and the battery compartment is protected by a basic, almost TV-style remote control cover. The front of the load cell features three buttons offering the following functionality: Zero, Units, On/Off. This is also reflected in the remote that’s supplied with the load cell, however, this also has extra buttons allowing peak hold and then a selection of buttons that appear to do nothing.”

Load cell's IR remote control (with limited functionality)

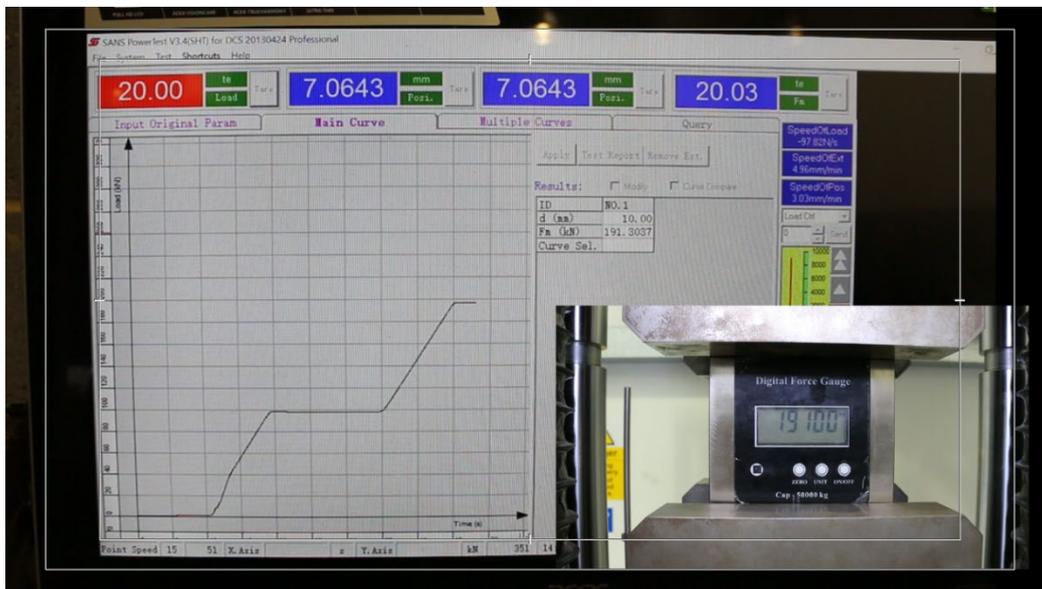
2nd Measurement

Force endured	20te (20000kg)
Force registered by load cell	19100kg (19.1te)
Inaccuracy amount	900kg (0.9te)
Inaccuracy percentage	4.5%

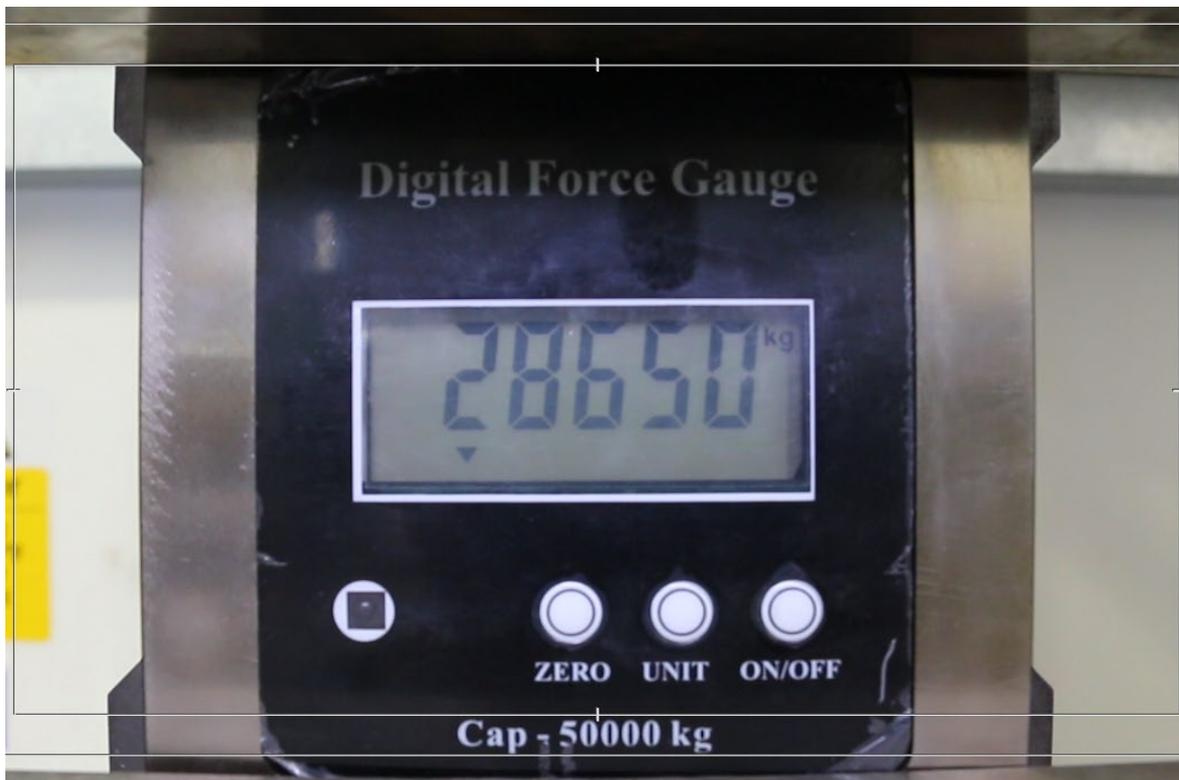
Reading when unit is set to kg:

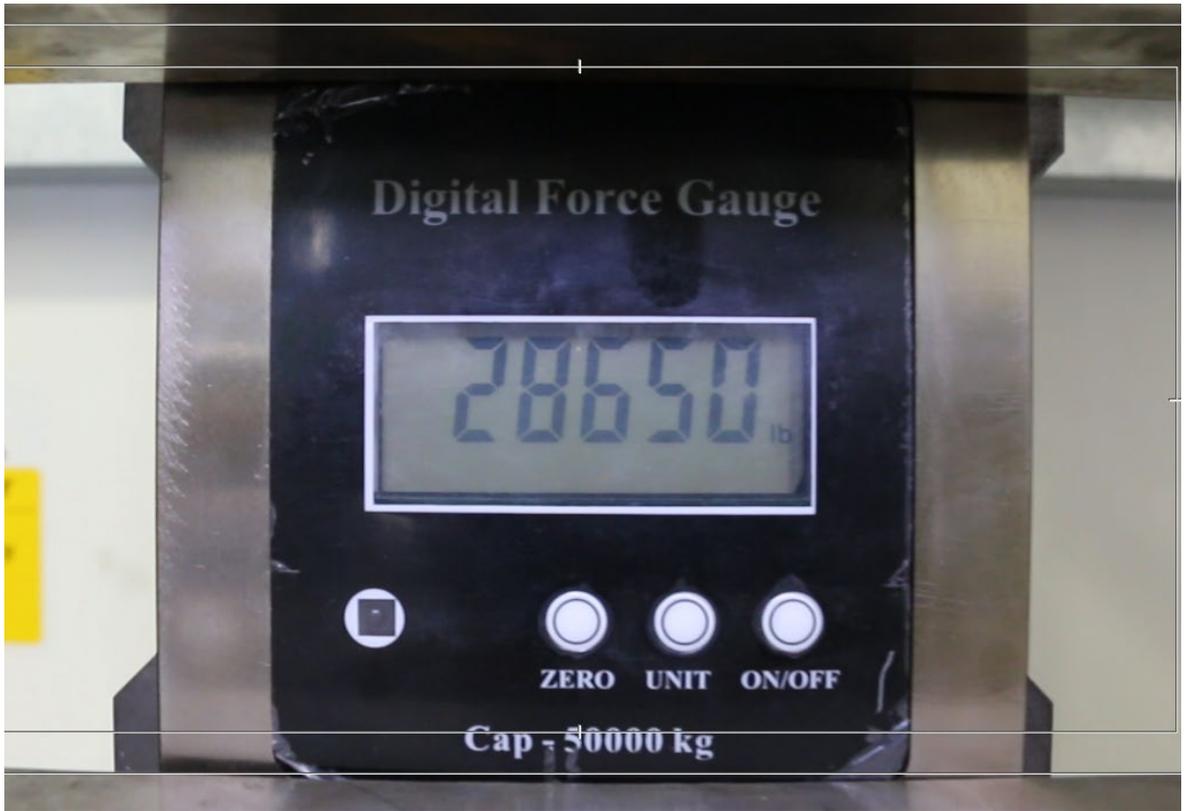
Reading when set to lbs

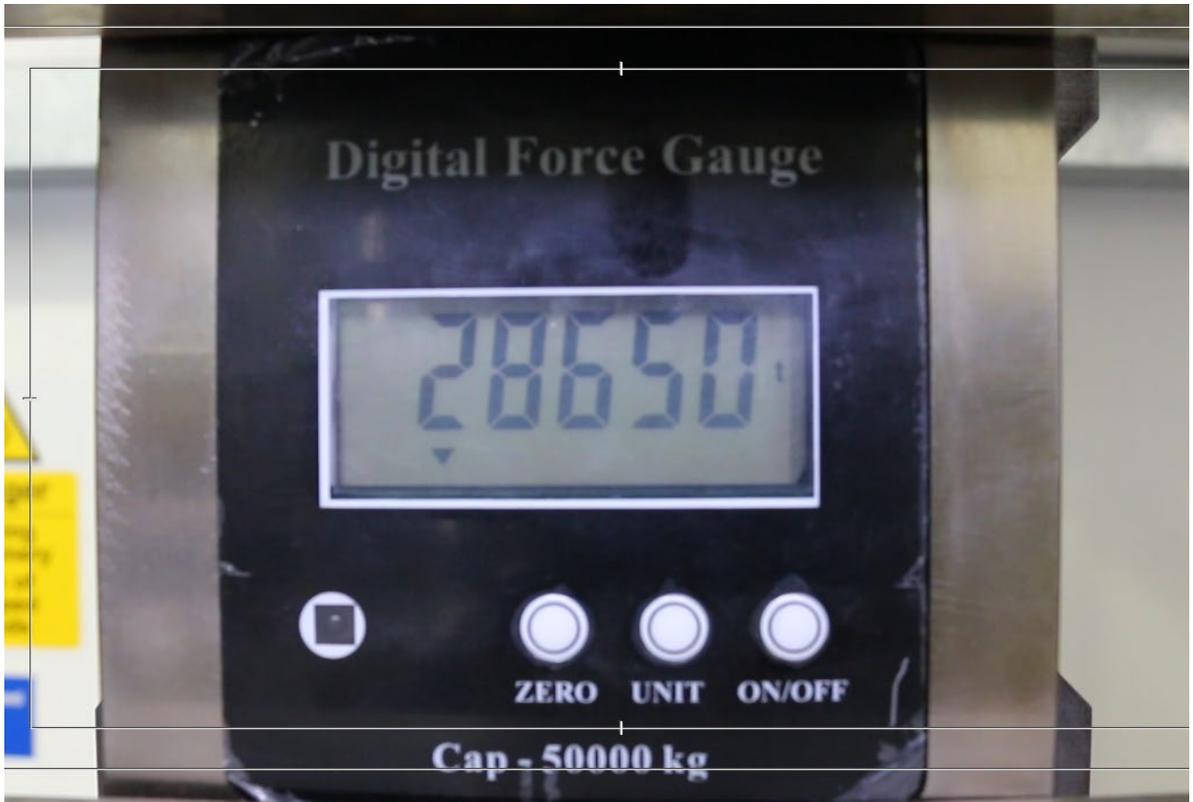
Reading when set tons (te)

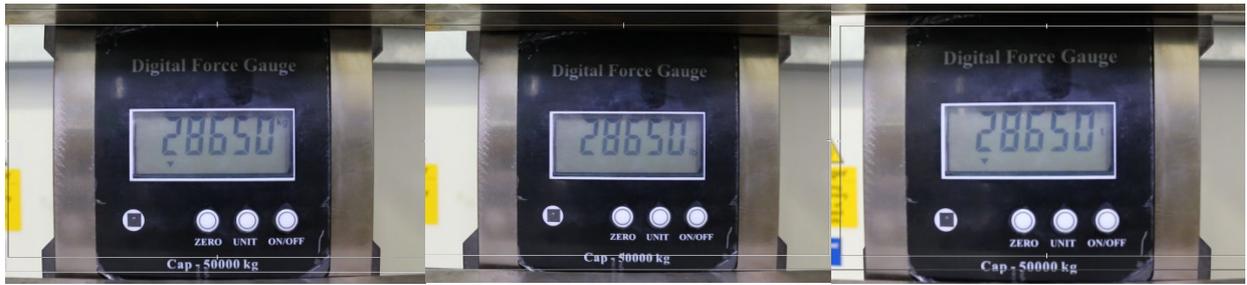
Side-by-side comparison

*“What this testing did confirm is that despite the load cell offering three units, this makes no difference as it always outputs in kilograms. **This is extremely dangerous as if it were being used in pounds without sufficient checks in place it would provide erroneous readings which at the least will halt any lift it’s used on, or in the most extreme cases cause injury.**”*

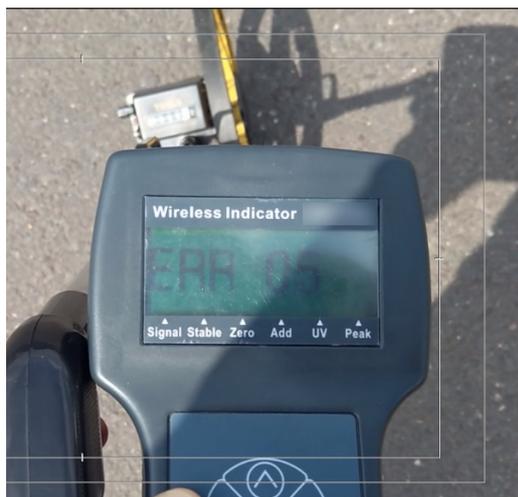
Figure A – Handheld device showing ‘ERR 05’ code saying that it has lost wireless connection with the load cell

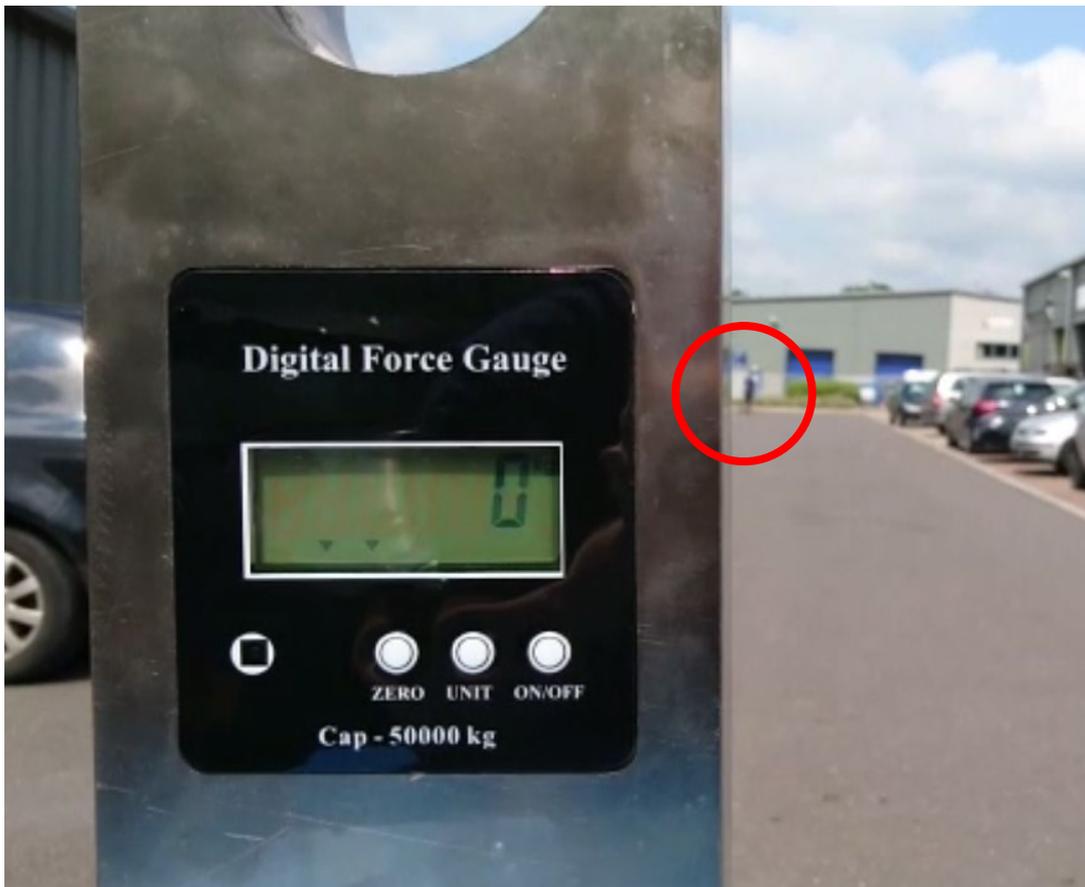
Figure B – Showing test setup with handheld being walked away from load cell by tester

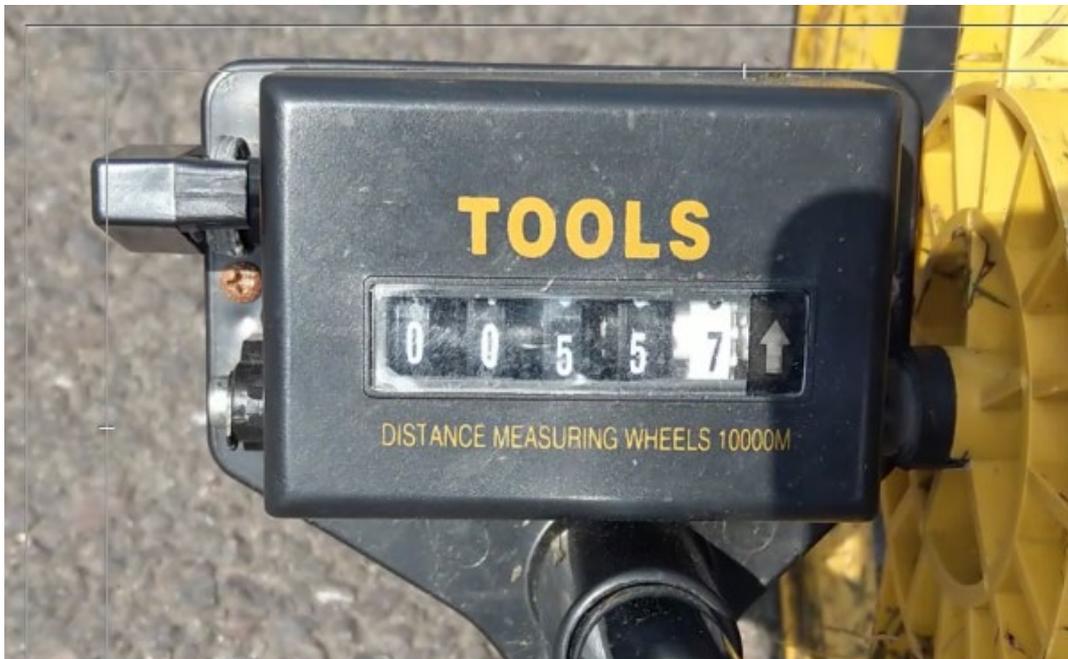
Figure C – Distance the handheld was away from the load cell (using a measurement wheel)

Test No	Line of sight?	Distance measured
1	No	53.2m
2	No	57.9m
3	No	56.0m
4	Yes	63.1m
5	Yes	58.1m
6	Yes	55.7m
Average distance:		57.33

- Load cell specifications state that the **minimum** distance for the wireless connection should be 80m. Our tests show that the handheld lost signal more than 30 meters under this minimum on average.
- It made no difference where the front side of the load cell was pointing whilst measuring the wireless connection distance, meaning the load cell’s wireless signal broadcasts omnidirectionally. SP load cell’s wireless telemetry signal strength goes out further from the front face of the RLP.
- For any large lift even around 80 meters would still be considered by any lifting professional as being an unsafe distance away to monitor the situation. The fact that the lifting manager would need to be as close as less than 60m to even get an adequate signal would be unacceptable and would be putting that person at risk.

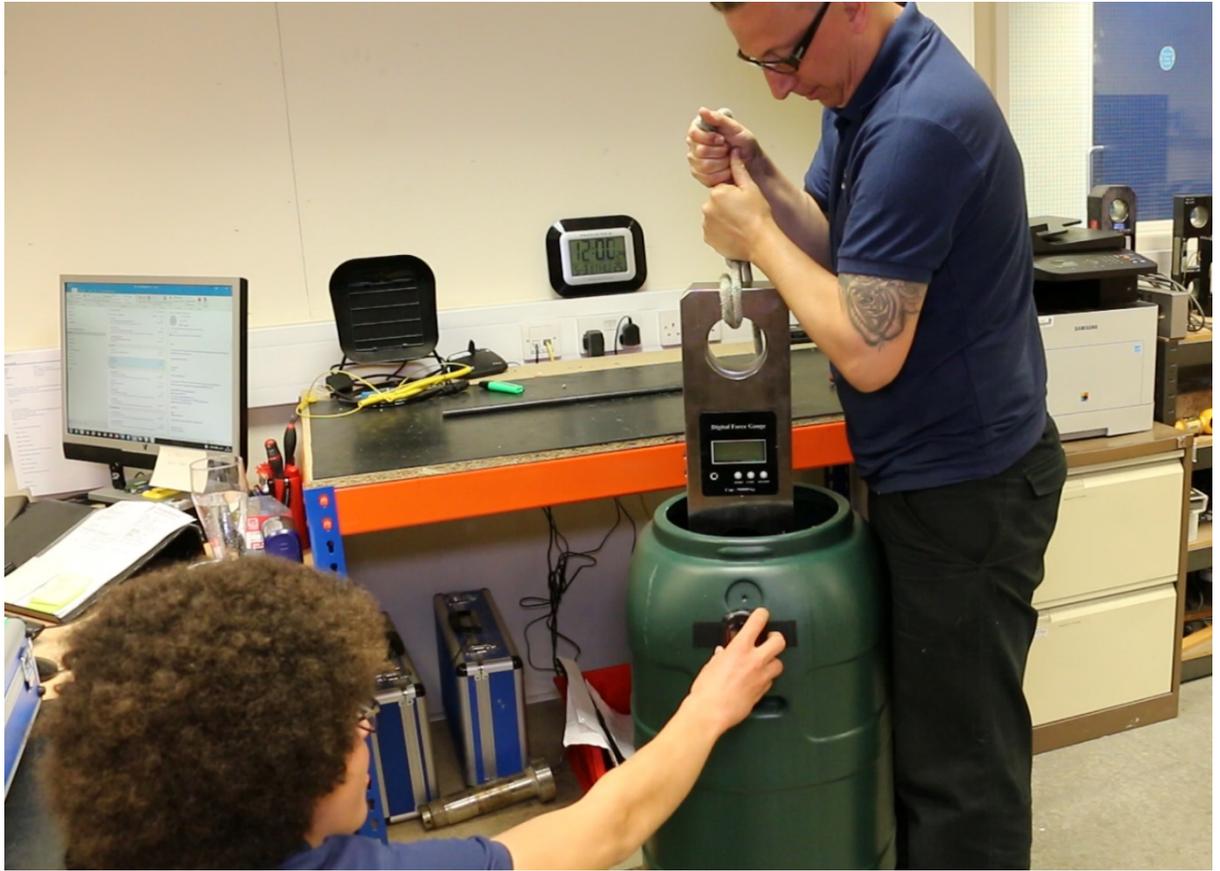
We filled a 1m-high water bucket with water and fully submerged the load cell. As soon as it was submerged we started a stopwatch so we could remove the load cell as soon as 30mins had gone by. We would then place the load cell into a bucket to collect any water leaking from within the load cell and to also open it up to check for internal moisture.

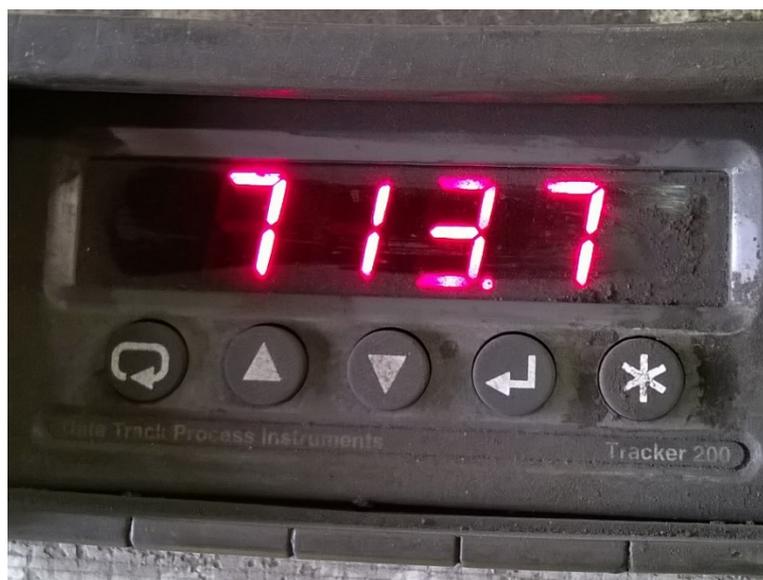
- The load cell surprisingly, and disconcertingly, yielded at 71,370kg / 71.37t.
- This is only 142.74% of stated capacity
- Which means that it was 128.63t (257.26%) off its "Ultimate load" or safety factor.

Destruction test machine's reading at the point where the load cell snapped (71.37te)

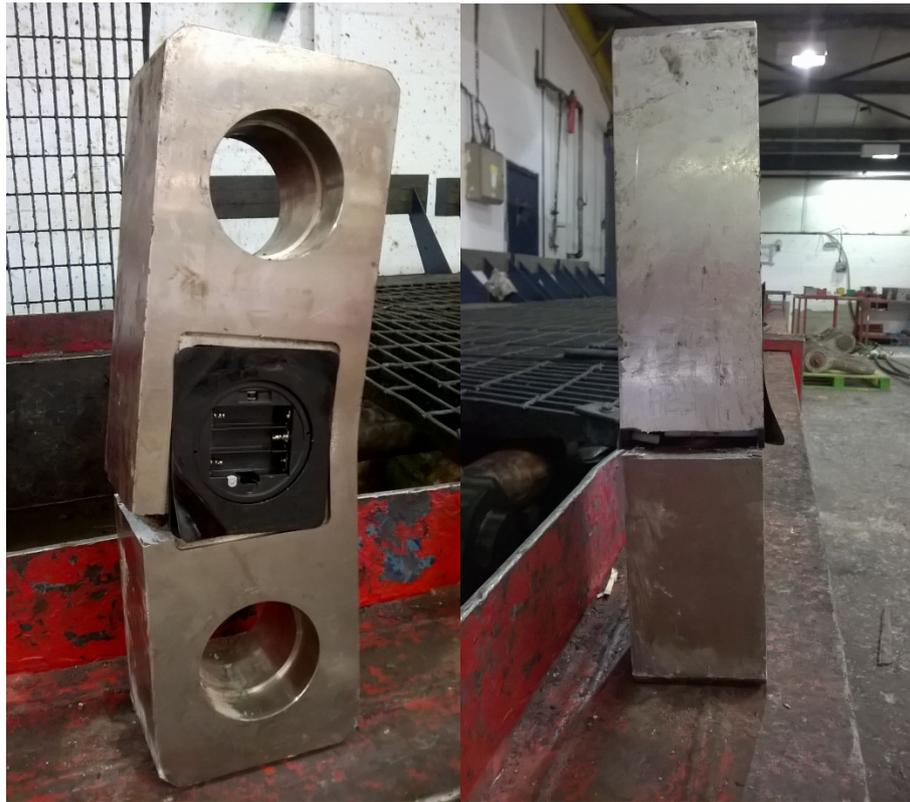
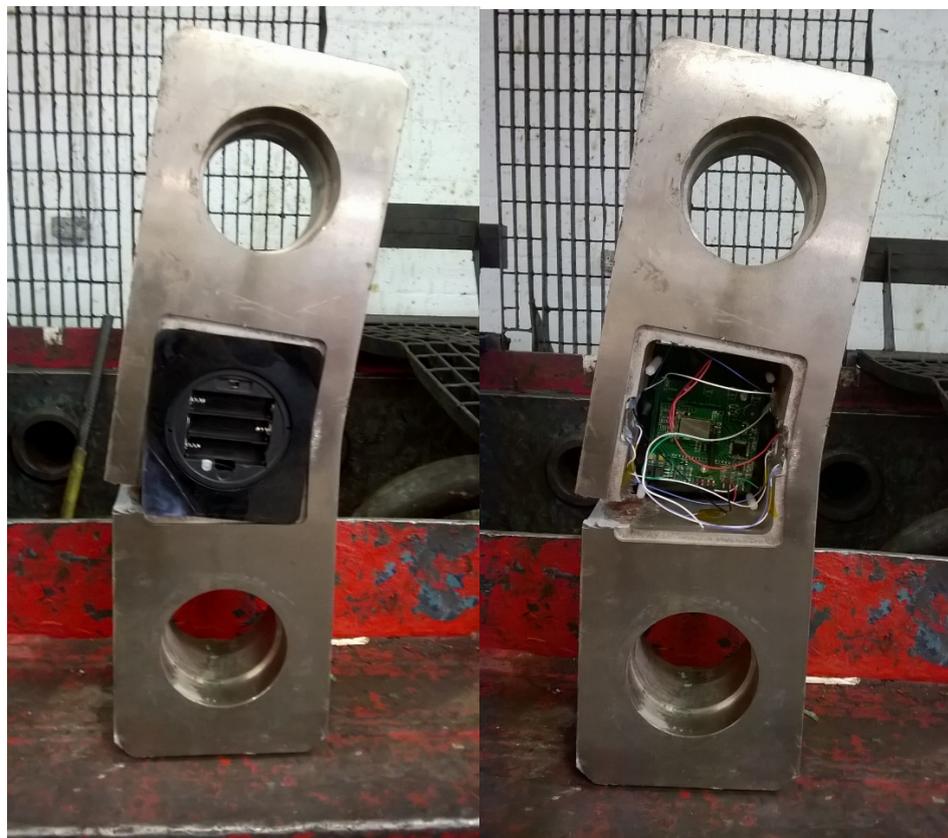
Photos of the load cell after it has yielded in the destruction test. As you can see it has snapped only on one side, which is highly unusual:

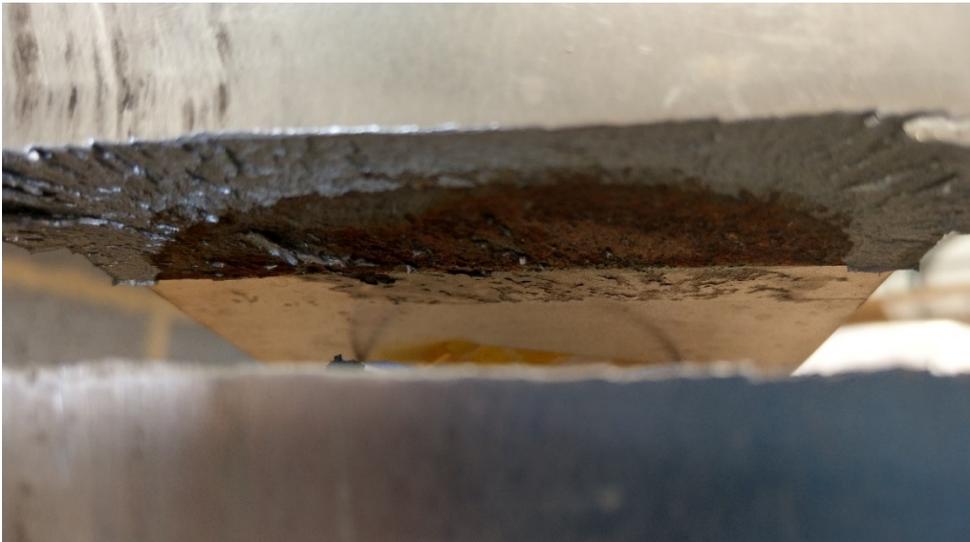
Extreme close up looking up into the snapped fault point

- After further inspection it was found that there had been a fault in the metal right at the point where the load cell snapped.
- The fault had rusted where the water from the IP water dunking test had ingressed through tiny fractures in one corner of the central void, into the fault.
- Tiny fractures can be seen in the oxidised metal fault area.

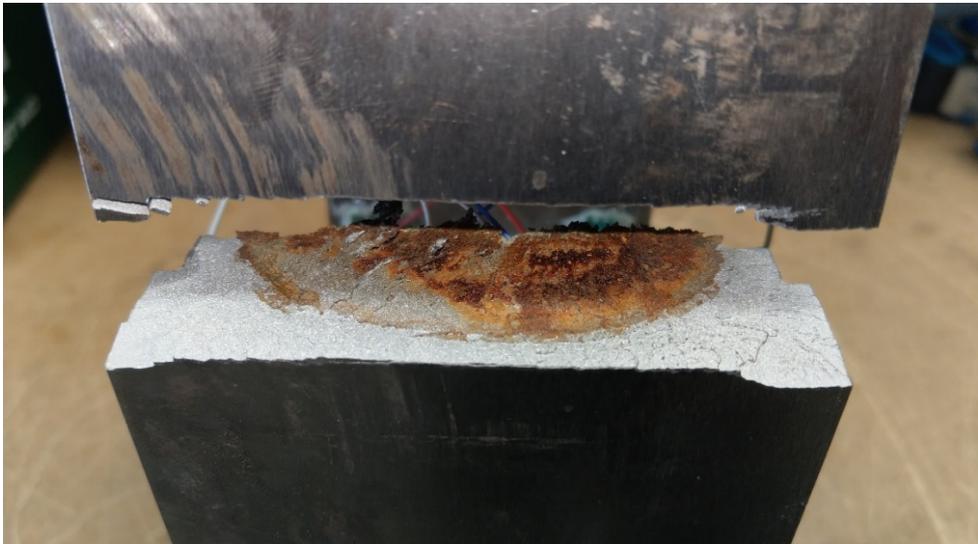
Extreme close up looking down into the snapped fault point

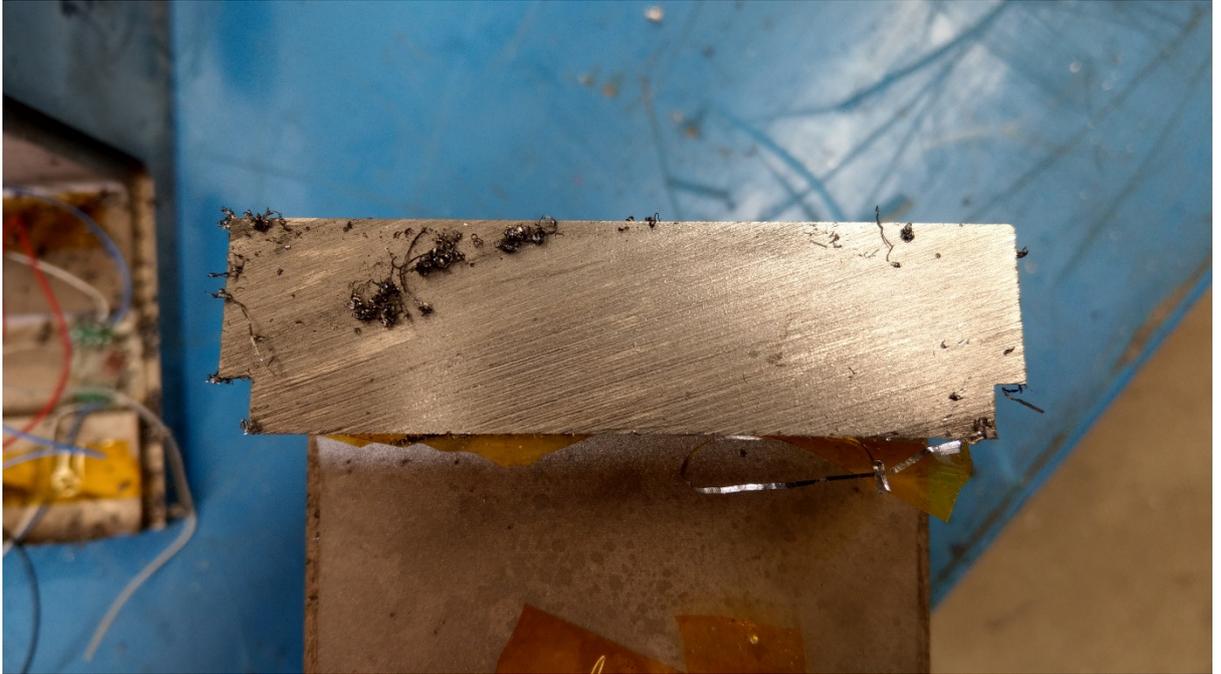
Top down close up shot of freshly cut through side that did not snap in the destruction test

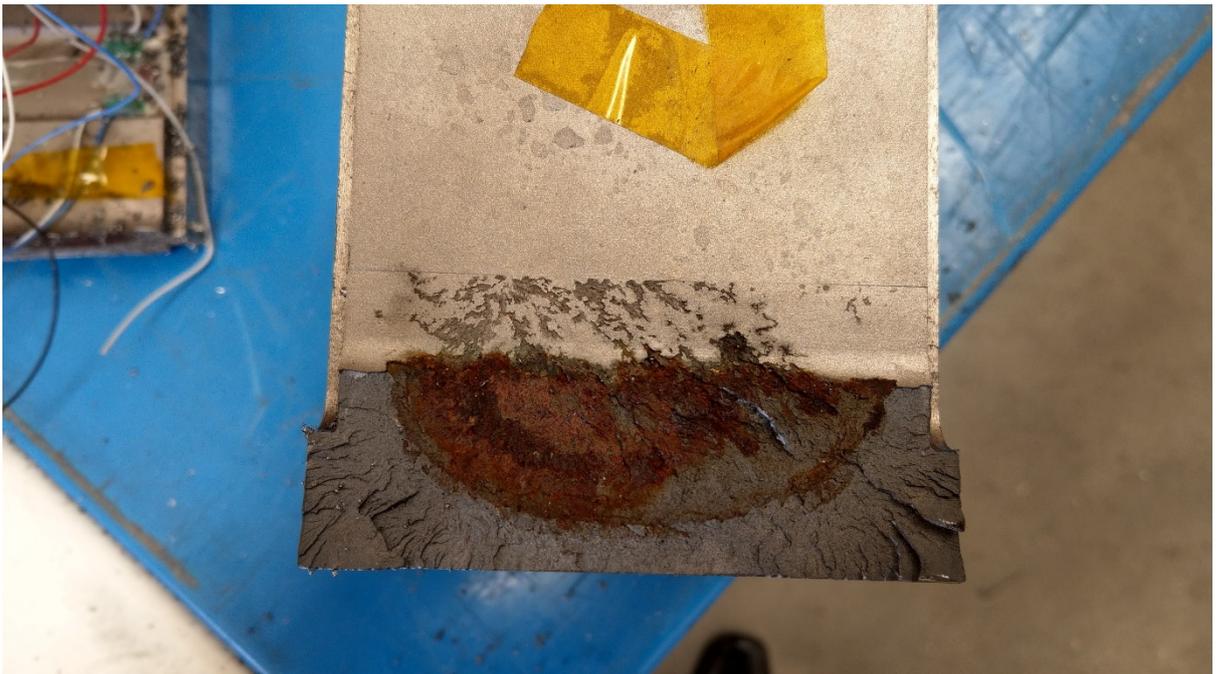
Top down close up shot of the side that snapped in the destruction test
